# THE WELLS BARN

**MCM**  
MILES • McCLELLAN  
CONSTRUCTION

## Project Information

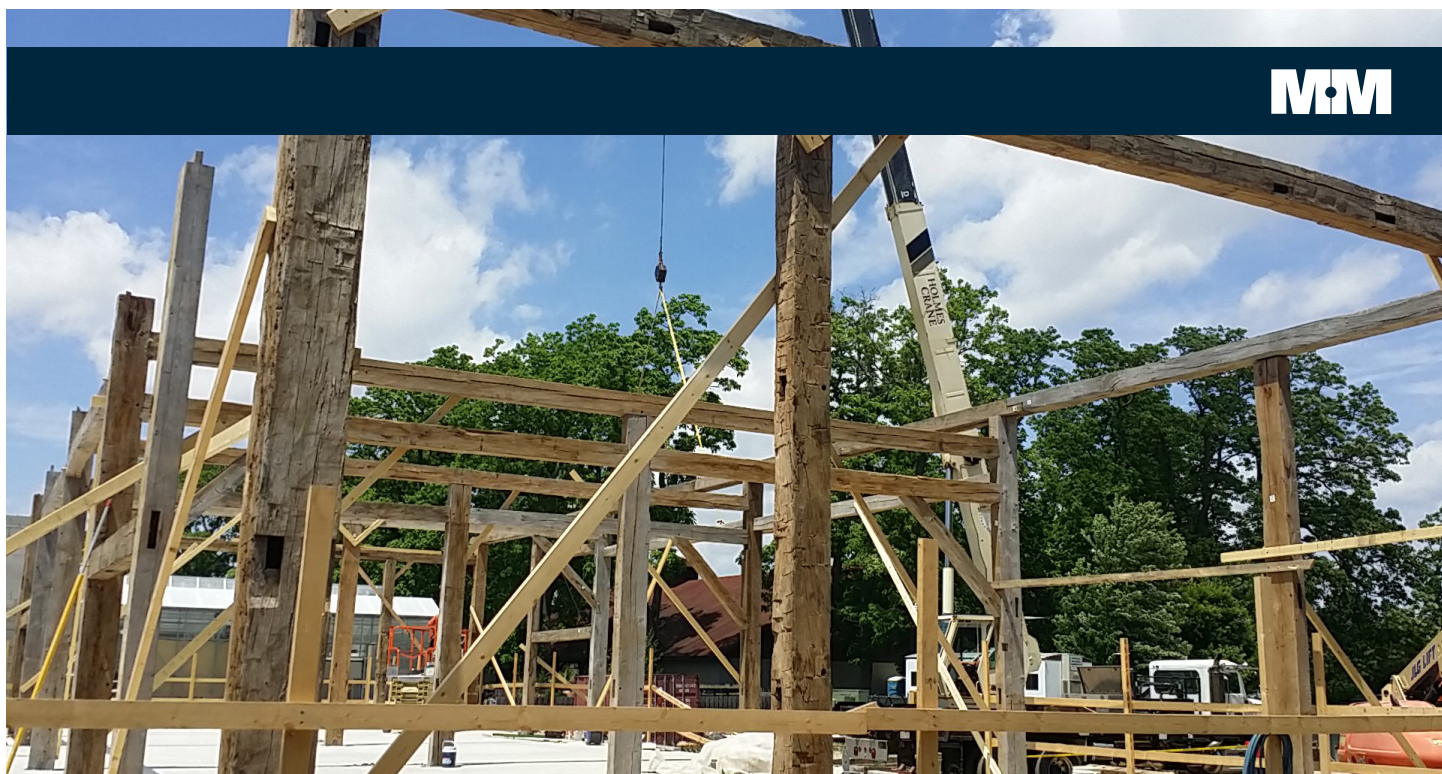
Notches from the original rafters were strengthened with wooden wedges.

A problem quickly arose as the crew began to stand the original timbers (see top photo). The bases of the beams were rotten, and 6" was cut off to reach usable wood. Cutting 6" off the bottom lowers the roof 6", eliminating the necessary space needed for the MEP systems. To regain the lost height, the team used new 2'x6' rafters, and used wooden wedges strengthened the notches from the original rafters.

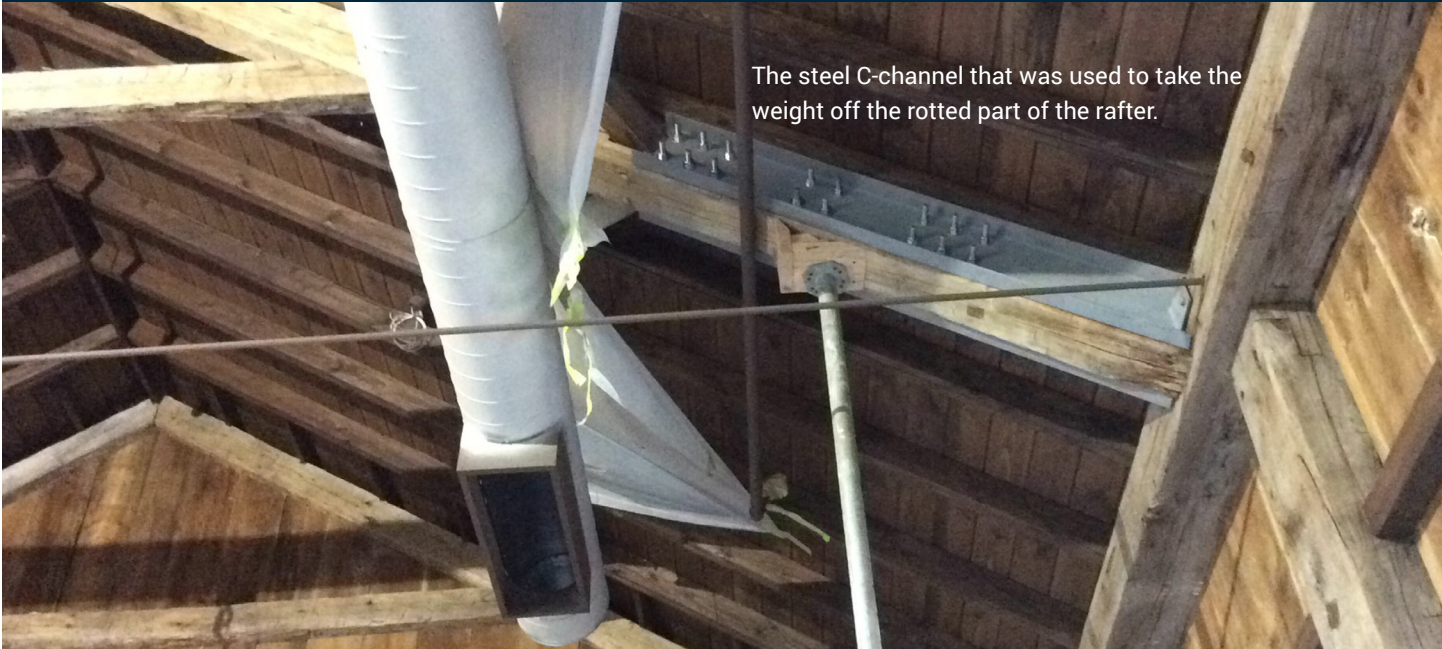
The steel C-channel that was used to take the weight off the rotted part of the rafter.

One of the main roof rafters from the original barn used as support was rotten on the North end. For this reason, the beam was not able to sit on the rafter plates, presenting a major structural issue. After a week of collaboration with the structural engineer, the team found a solution. They used a large steel C-channel to take the weight off the rotten part of the rafter (see top photo next page). While that fixed the support issue presented by the rotten wood, another major structural issue was discovered at the South end.

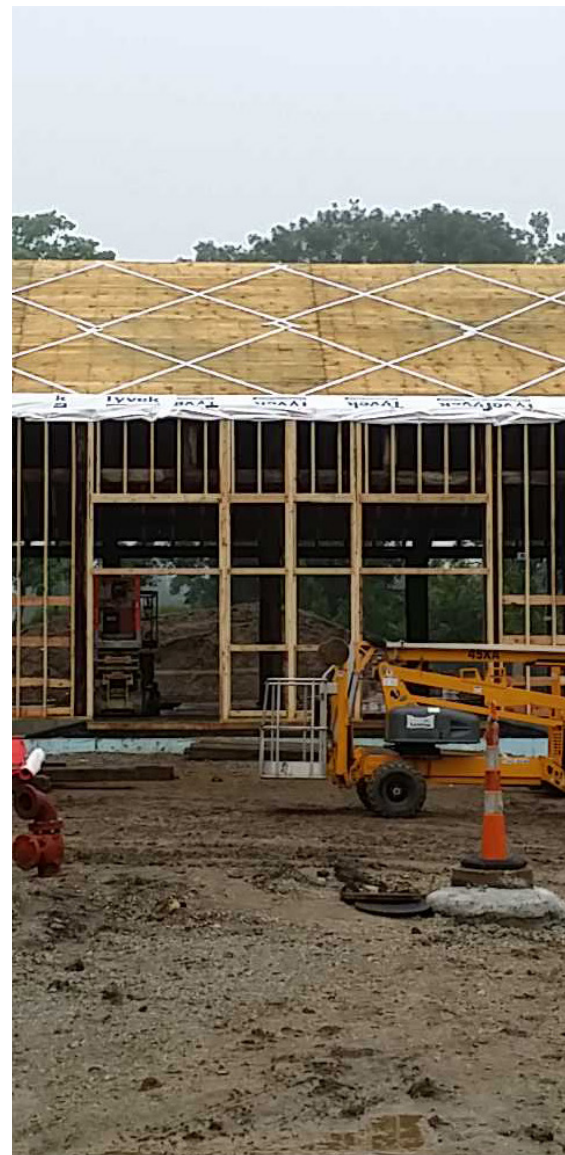
Generally, the main challenge of this project was the securing and stabilizing of the structure. A lot of reinforcement was used, such as using engineered PSL beams to support the cupola, stabilizing the roof using twenty (20) different types of Simpson ties (see right photo) along with the other issues mentioned above. To compensate for the extra work required to secure the structure, the team began interiors before the roof was 100% complete and dried-in. Every detail of the interior trim had been hand-measured and cut to work around the non-square structure.
